August 11, 2016

Project No. 16-139-37

**Re: Pre-Renovation Designated Substance and Hazardous Material Survey
Bartley Conference Centre Renovation
Lakehead University, Thunder Bay, ON**

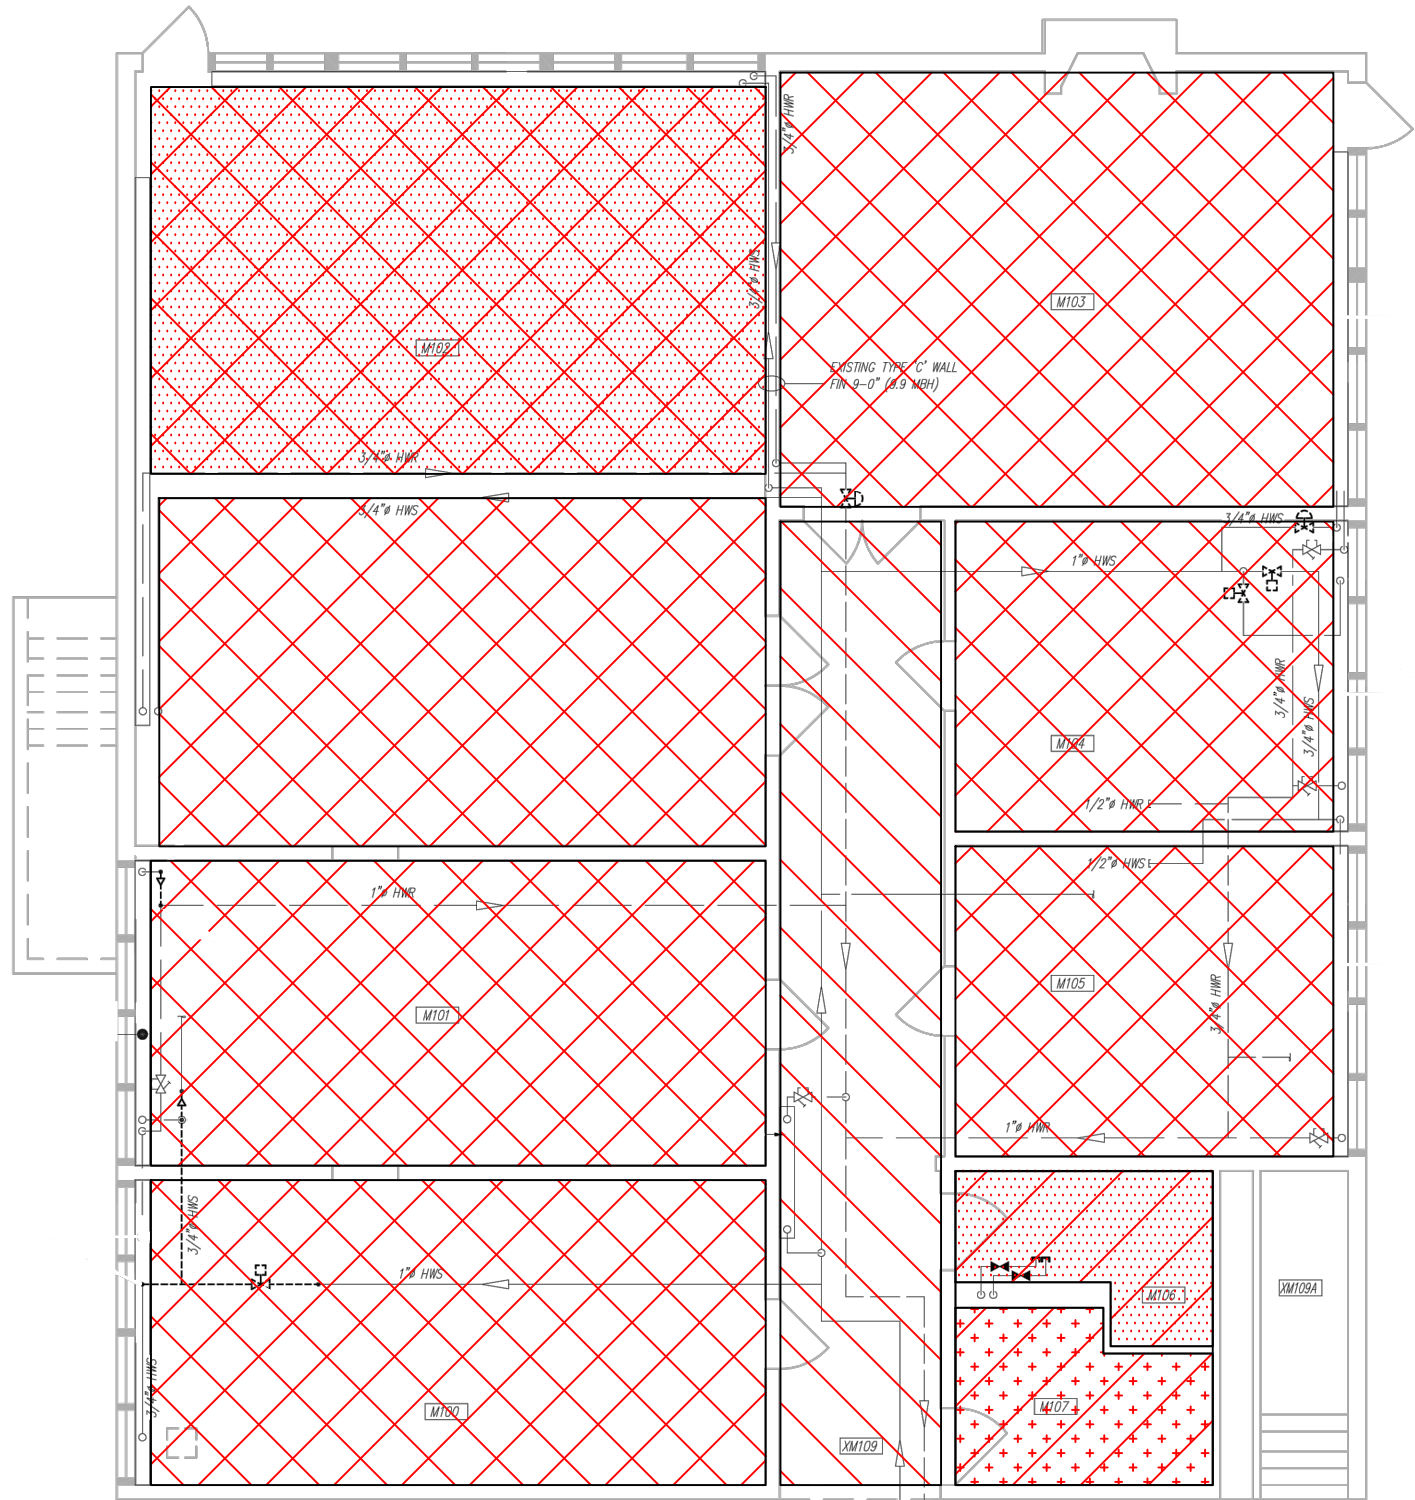
Figures - Sample Locations and General Location of Identified ACM

P	TSI	parging cement on elbows	VS:S5	YES	Chrysotile (25%)	F-P	Y	Observed on insulated piping above the gypsum board ceiling. 2 fittings were observed.
		P	TSI	fibreglass insulation under canvas wrap	visual ID	NO	--	--	--	Observed on insulated piping above the suspended CT. Non-asbestos fibreglass insulation was observed on the straight sections of the pipe.
	Lead	W	Paint	light brown	HMIS	YES	--	--	--	Paint was observed on gypsum board.
		O	Paint	dark brown	HMIS	YES	--	--	--	Paint was observed on metal frame.
		C	Paint	white	HMIS	YES	--	--	--	Paint was observed on gypsum board ceiling.
		O	Paint	brown	HMIS	NO	--	--	--	Paint was observed on wood doors.
	PCB	O	O	Ballasts in fluorescent light fixtures	visual ID	NO	--	--	--	Fluorescent light fixtures observed in the area were fitted with T8 bulbs. Due to the recent introduction date of T8 light fixtures, the ballasts associated with these lights are not expected to contain PCB.
